"Engine & Secondary Ignition Physical Part 3" restoration article is inspired by the upcoming May 2019 "Tech Event" being hosted by the Nichols at their home.

Part 3 covers applying this knowledge to an example; 65 Dart(Slant Six) with excess secondary voltage measured in the 2018 Engine Secondary Ignition Physical. Applying the theory of only changing one thing at a time the 2019 65 Dart Ignition Physical was performed (Trail 1) after altering the design of the spark plug wires by changing wire types & altering routing for the unique slant 6. Wire types originally were 8.5mm EMI & were changed to 8.5mm non EMI:

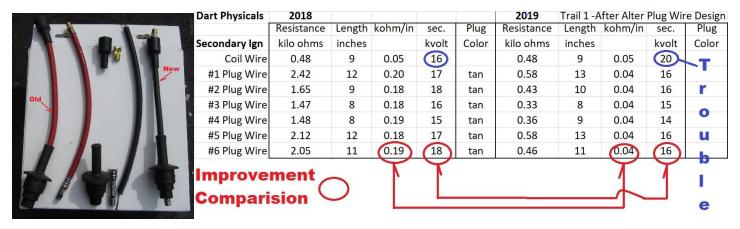
Plug Wire Secondary Voltage dropped 10% which is not enough; this points to the plug itself as needing attention (plug resistance downstream of our plug wire Volt measurement is suspect).

Also note that over the course of the year the coil wire voltage is showing increases even though plug wire resistances had dropped. Something else must also be going on and the distributor cap terminal to rotor condition looks suspiciously high on the list of items to exam.
