Balancing Tail Light Intensities article is the result of a Colonial Region member pointing out that the brightness of the lights appeared out of balance on the rear of my 65 Mopar. There are 4 light assemblies in this case with the outer lights displaying brake & tail lights while the inner lights were tail lights only. A Tail Light Assembly consists of rim, lens, reflector, and gaskets:

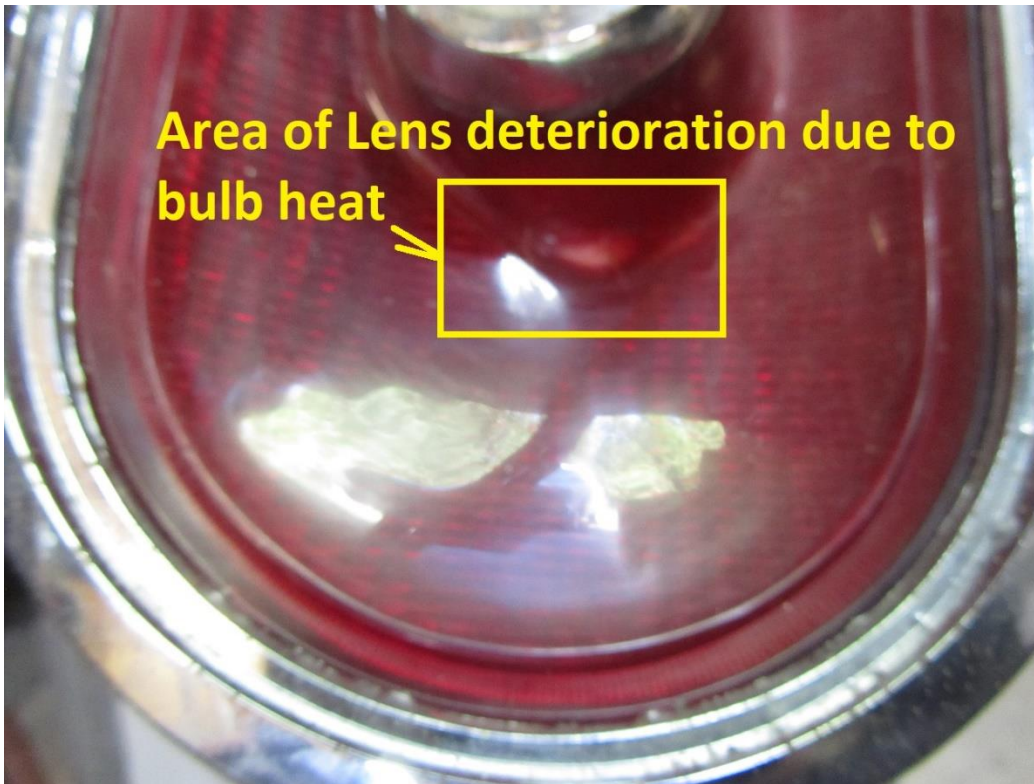
The overall theory was that not only were the effects of gasket, UV, dirt, and oxidization deterioration over time involved but also the original design involved high heat producing incandescent bulbs held close to the lens caused a significant lens failure. Have someone step on the brake for awhile and touch the lens (or use a temp gun) to see if your lens has a hot spot near where the bulb is located. If your current lens has distortion, has turned white, or cracked in that area your lens may be failing from the effects of the heat source placed too close too the lens such as in this condition:

The effort of cleaning, rebuilding, replacing defective components, adding grounds, and upgrading bulbs addressed the assumed causes of the brightness variations.

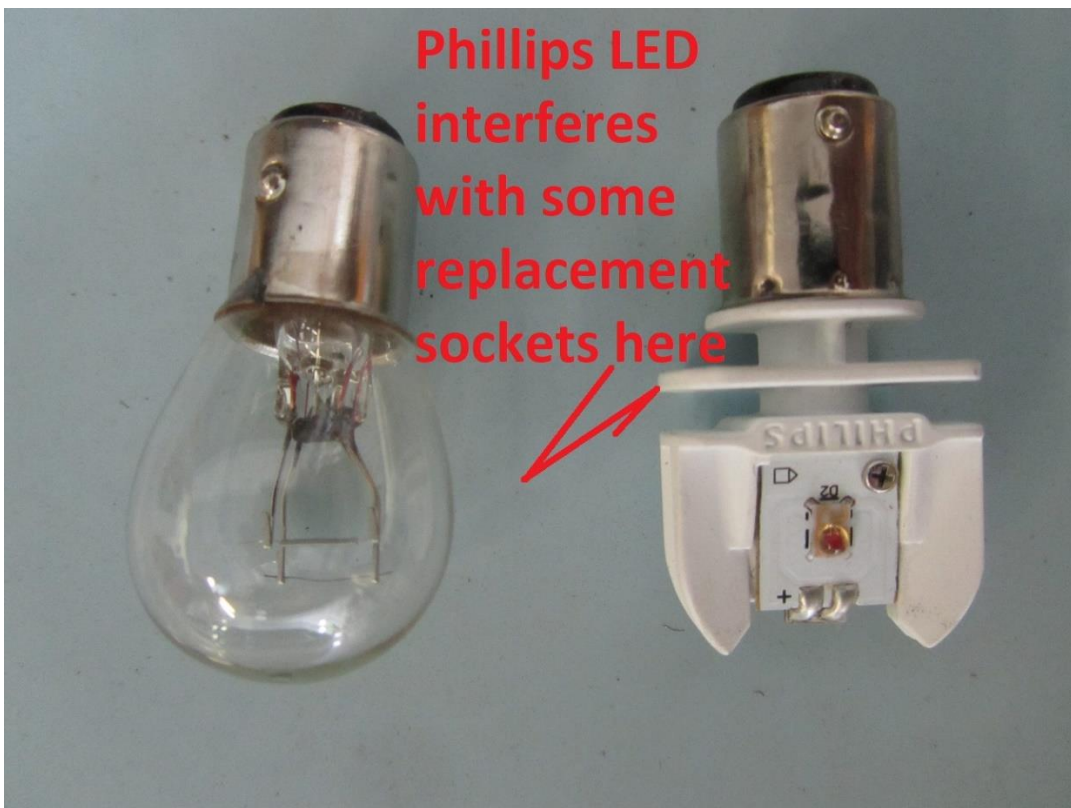
It should be noted that several type of LED bulbs were tried. Some Phillips LED bulbs interfered with the socket tangs and would not install into the replacement sockets:

The Sylvania LED called out in the below pictures did not have that interference problem.

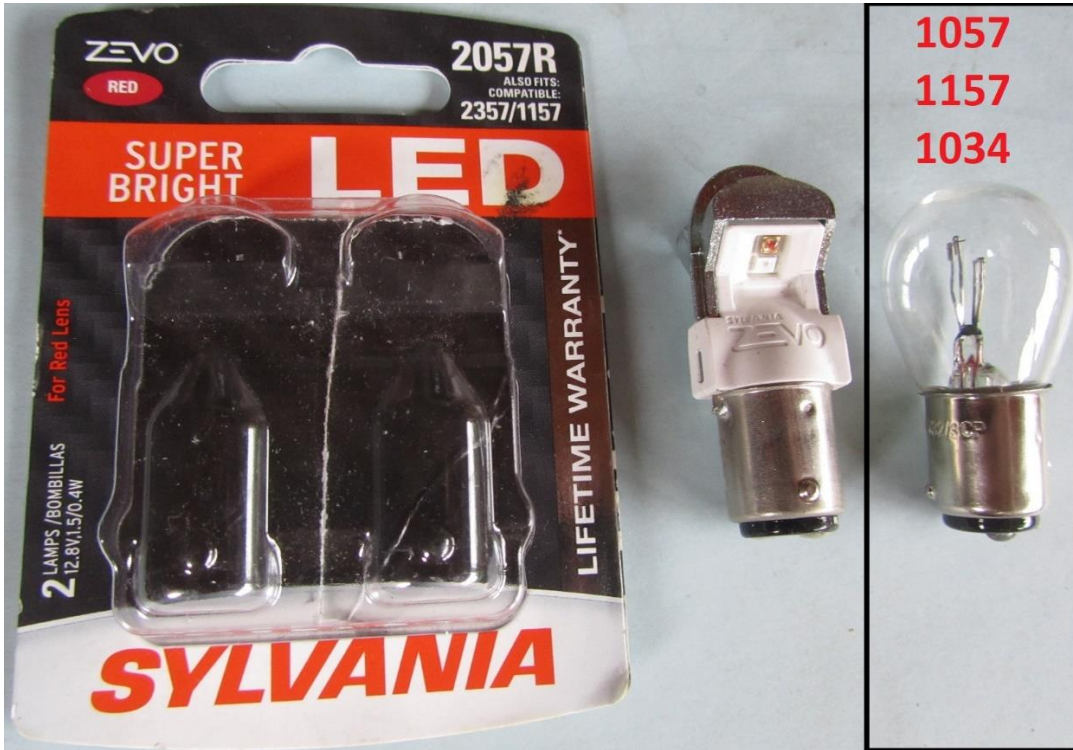
Incandescent & LED Comparison:

The effort paid off with not only brighter, uniform lights but also a reduction in current draw (as noted on the instrument panel gauge).
