## Improve Carter BB 1 barrel idle and low speed operation

The attached images are for a Carter BB D6G1 (as used on 1942-48 Plymouth six) however most Carter BB are similar for this area of the carb as covered in this 49-54 Plymouth Carb parts diagram:

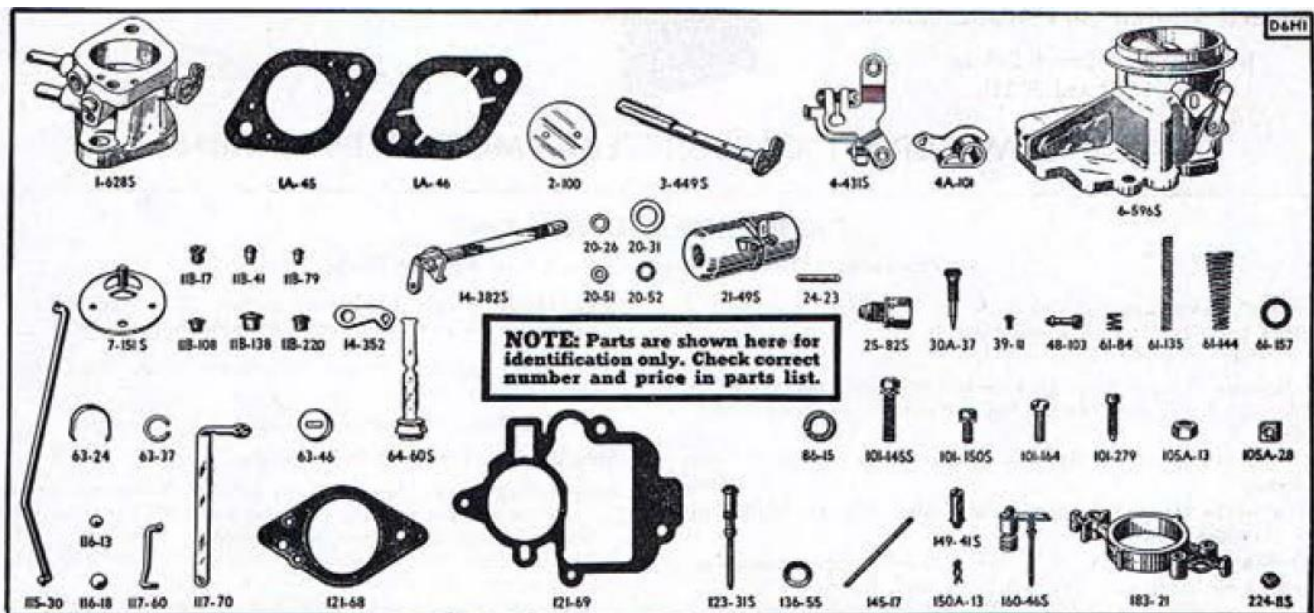
### Plymouth Carburetors Nos. D6H1-D6H2—1949-1954

The parts discussed are the Body Flange Assembly 1-628S including the 2-100 Throttle Valve and 3-449S Throttle Shaft and Arm Assembly.

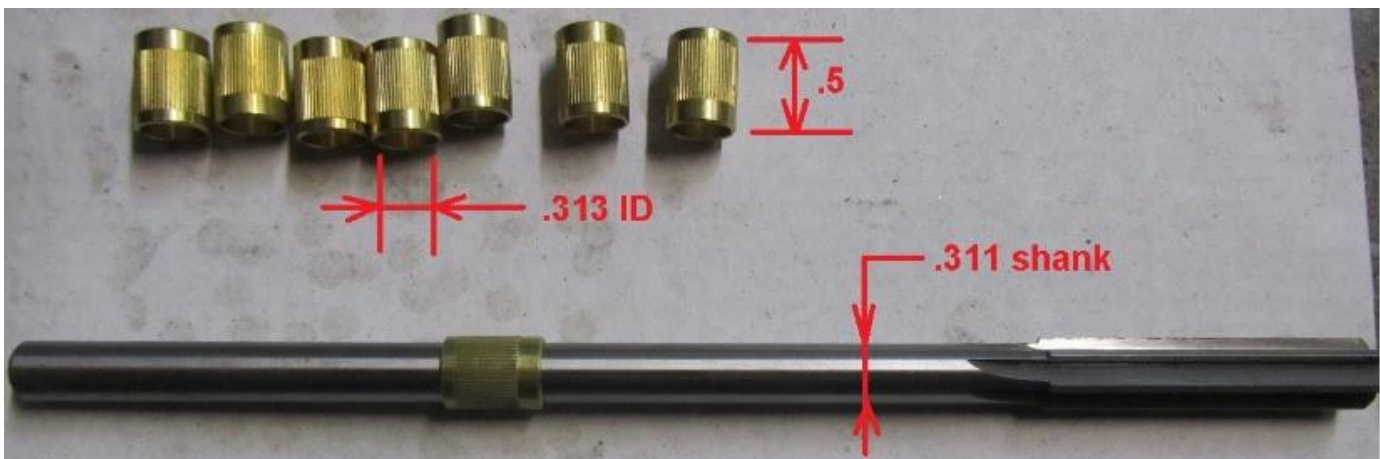
A reamer & bushing kit is available to repair the Body Flange worn areas. It is not marketed as a Carter BBS repair kit but it does the job with no problems. Carb Junky and Quadrajet sell such a kit marketed for Quadrajet & Holley 5/16" diameter Throttle Shaft repairs carbs. Kit looks similar to this:

The ½” long solid brass bushings fit one side of the Carter Throttle Body Flange perfectly and the remaining side (or end of the Throttle Shaft) needs the bushing filed off about 1/8” after installation.

The kit screws furnished are the incorrect size; 4-40 x 3/16” brass screws can be supplied from your local hardware store. At the same time you may want to pick up a #43 drill and 4-40 HS Tap so you can clean up the threads and/or repair any old screws that snap off when you are removing them from the Throttle Valve. Filing off any protruding Throttle Valve Retaining Screw ends before attempting to remove them might save you this time consuming step.

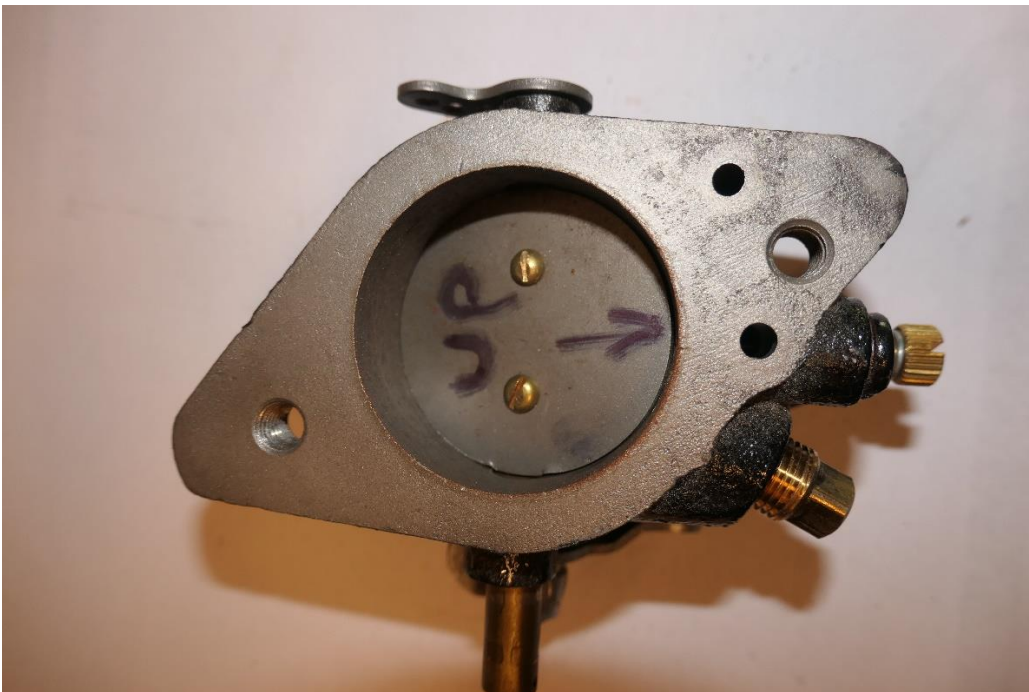
After removing the Throttle Body Flange from the carb mark the Throttle Valve with the “up” position and the direction facing the needle valve:

Remove the Throttle Valve Retaining Screws using a back and forth (counterclockwise to clockwise) method to try and avoid breaking off the low strength brass screws. Celebrate if you get out both screws without breakage otherwise you get the opportunity of drilling out the screw portion left in the bore and tapping with the 4-40 tap.

Remove Throttle Valve and Throttle Shaft and clean any corrosion off the flange wall. Good time to check the looseness of the shaft again so you have that reference to compare with the final end product of your efforts.

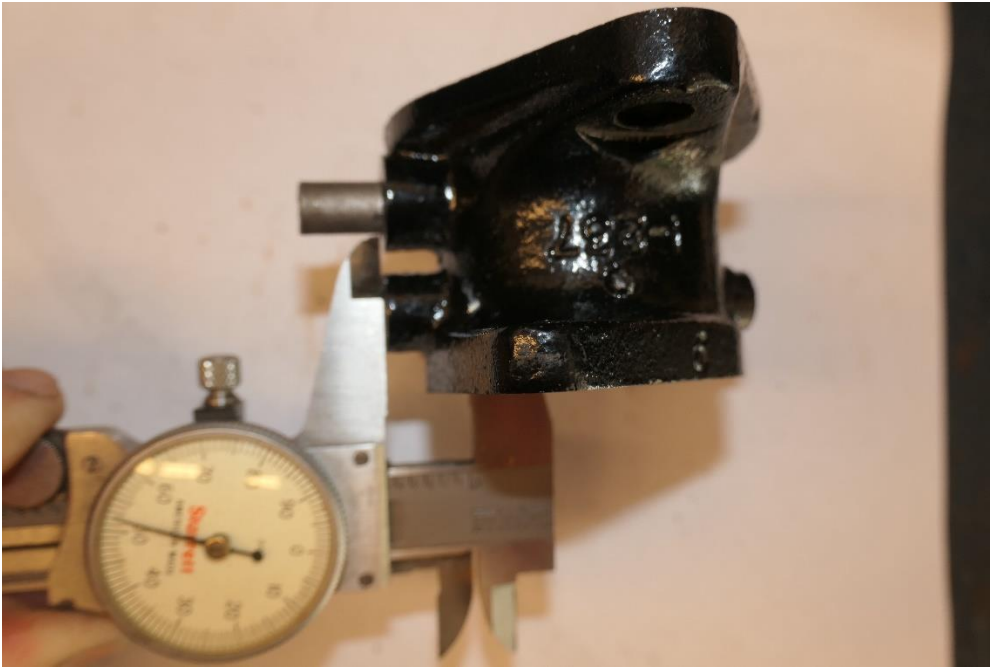
Measure each Throttle Body Bearing Area length:

These dimensions are used to determine where the reamer stop will be positioned to insure the brass bushing DOES NOT PENETRATE INTO THE THROTTLE VALVE AREA. Your goal is to insure the installed brass bushing goes in against a ledge. The ledge is the un-reamed portion of the bore left to act as a stop for the bushing.

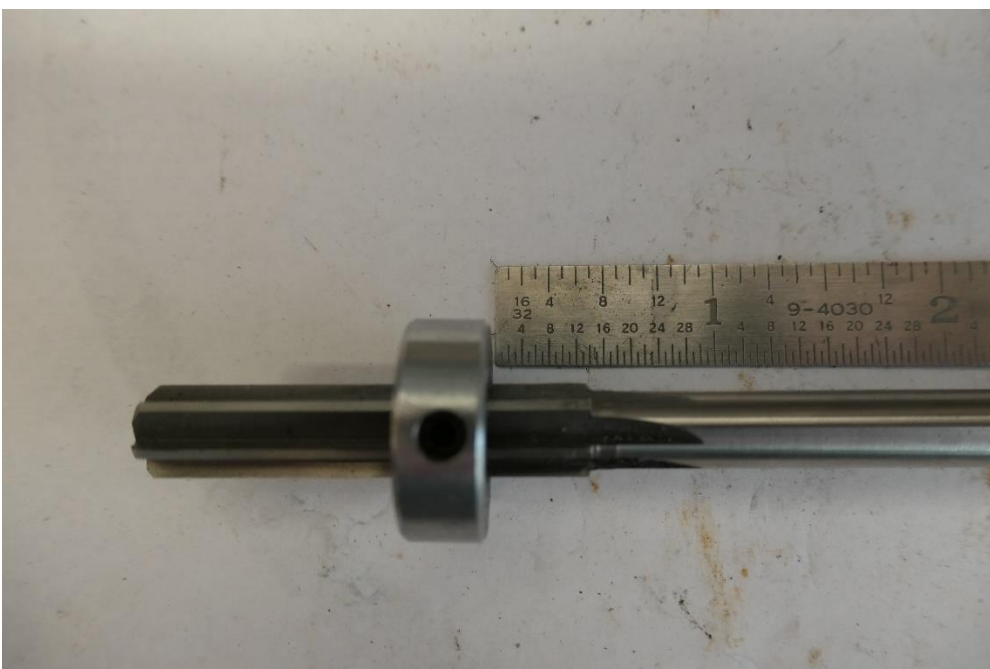
Set the stop (about 1/16" less than dimension) in position on the reamer:

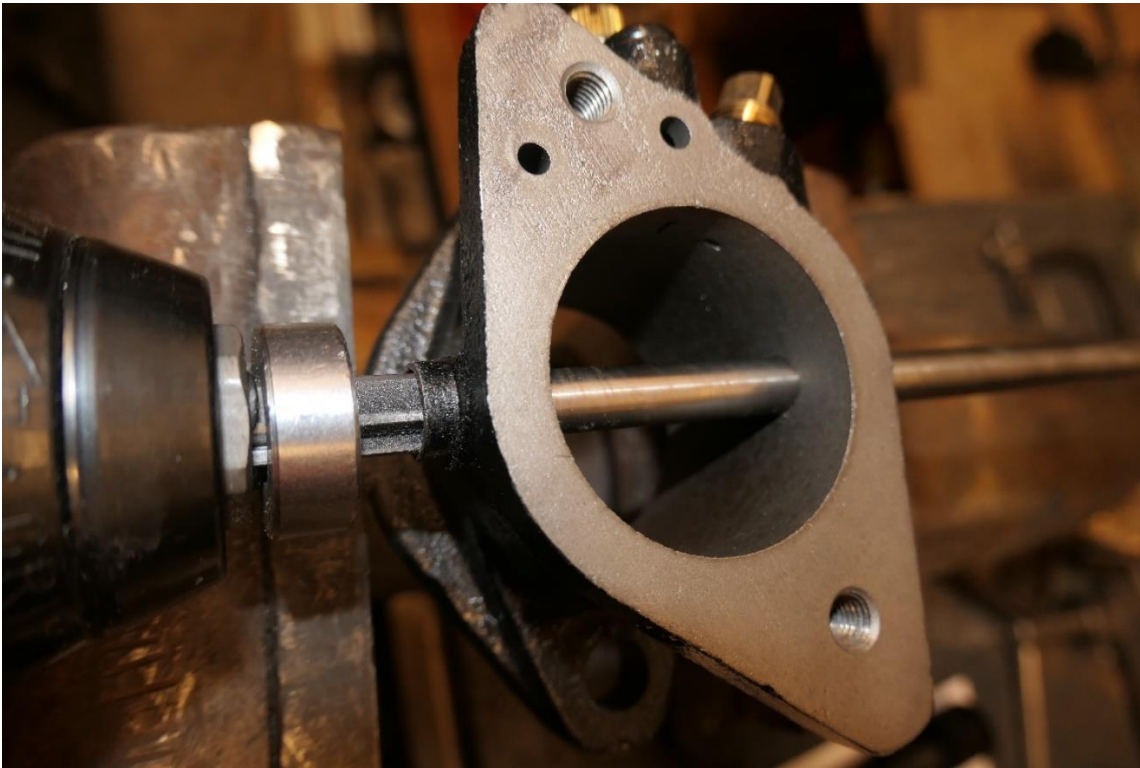
Mount the reamer on the drill so that you can exert a significant amount of pressure on the cut; it's not normal for an aluminum flange to do it this way but you are reaming an iron casting (lube didn't seem to help---made it worse):

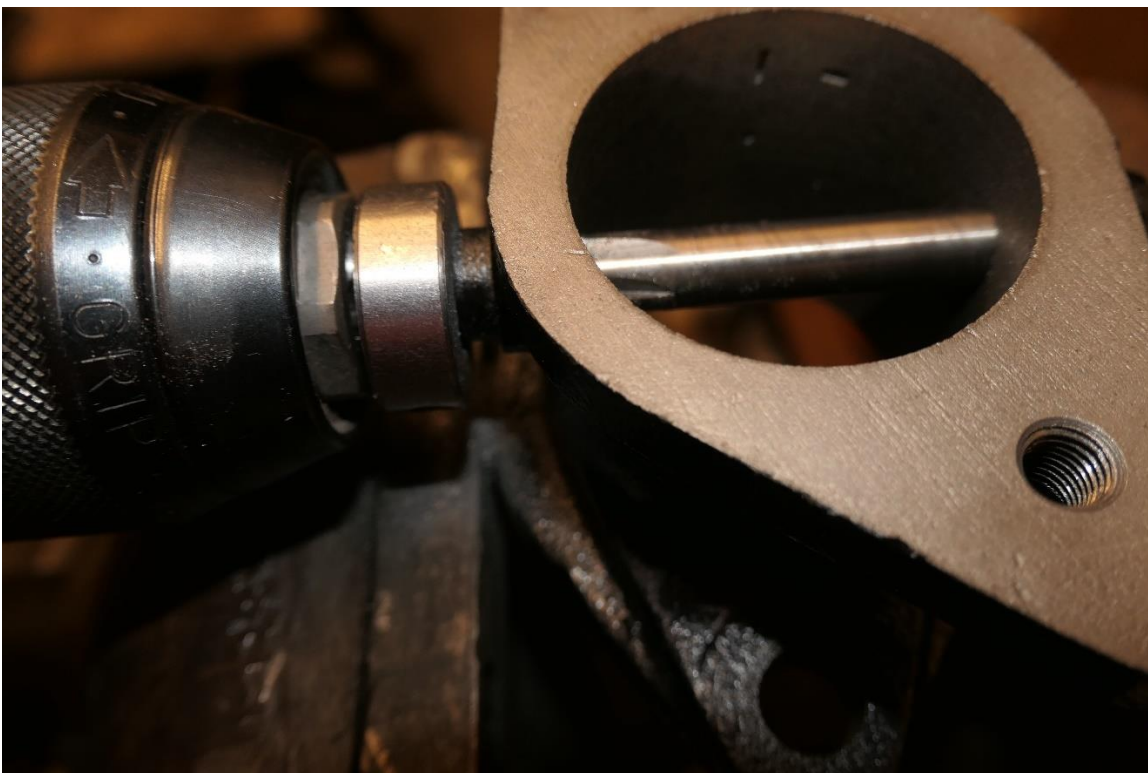
Machine until the reamer stop bottoms out on Throttle Flange bearing surface:

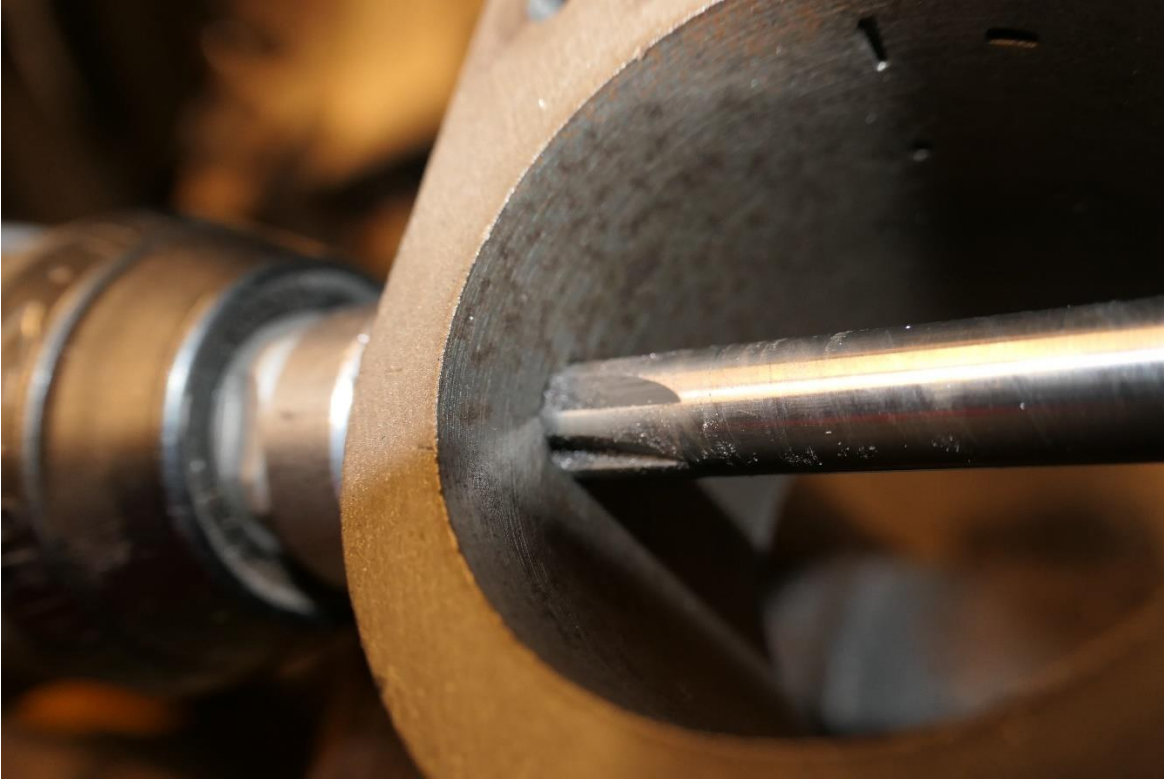
The reamer has the following appearance when the machining must end:

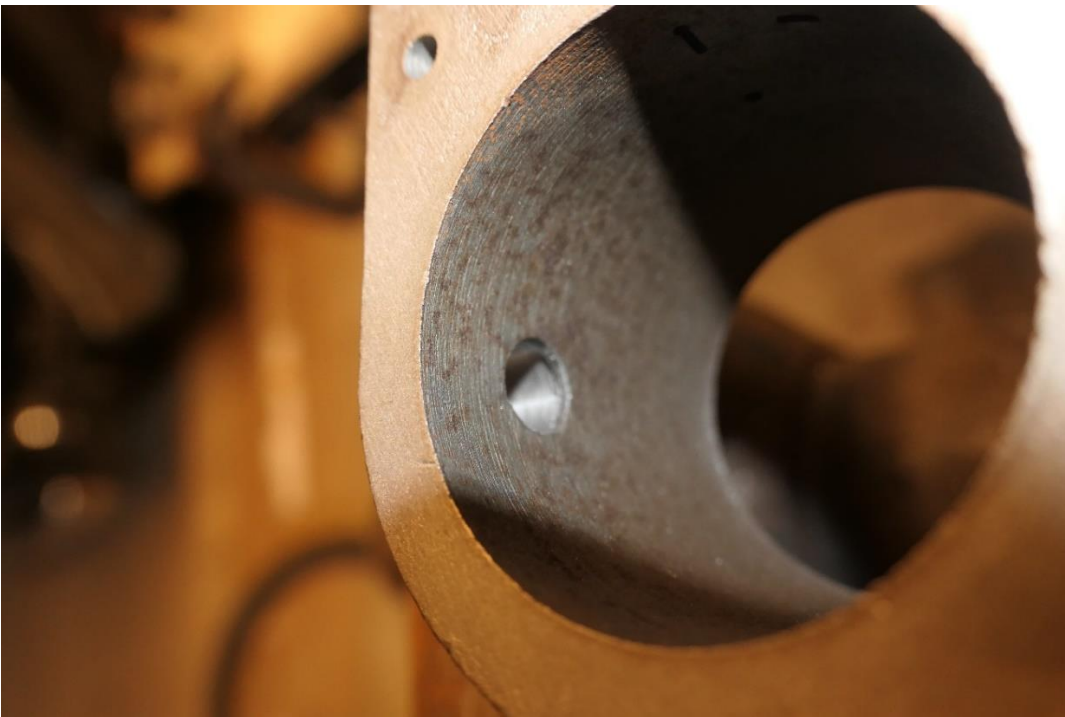
Once the reamer is removed a lip must be found on the inside of the bore:

The reamer is now used to do the other bore AFTER RESETTING THE REAMER STOP and installing the first brass bushing.

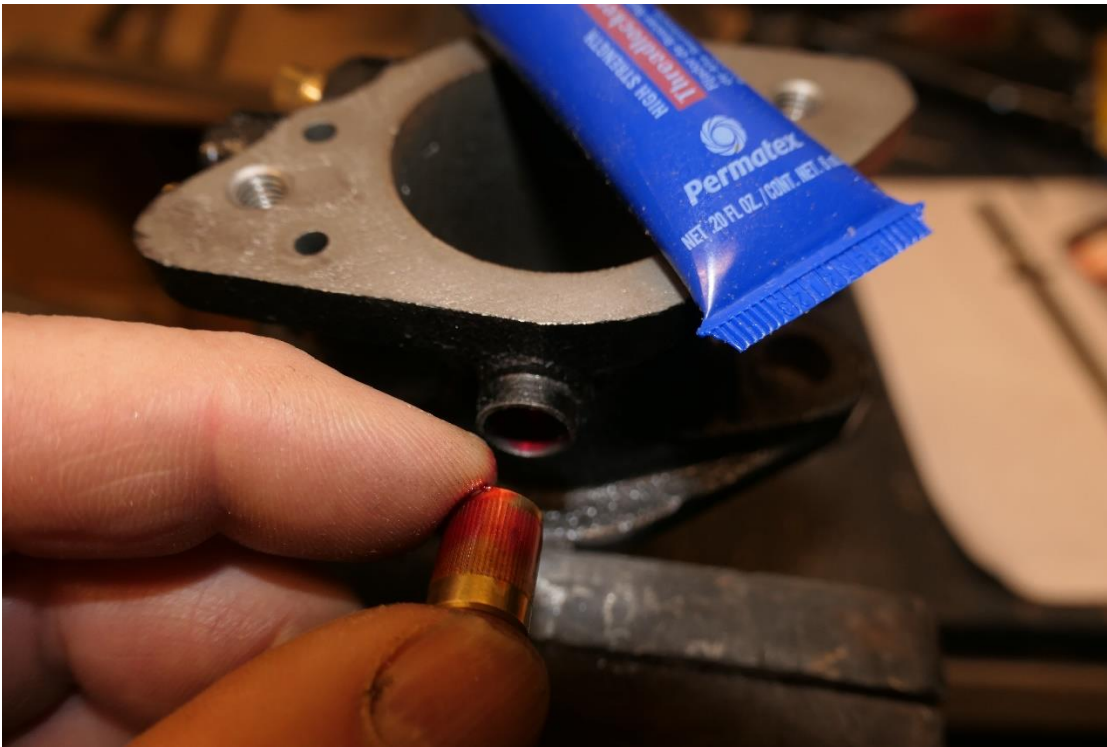
The first brass bushing can be installed using high strength Locktite to hold the brass bushing in place and also provide a seal:

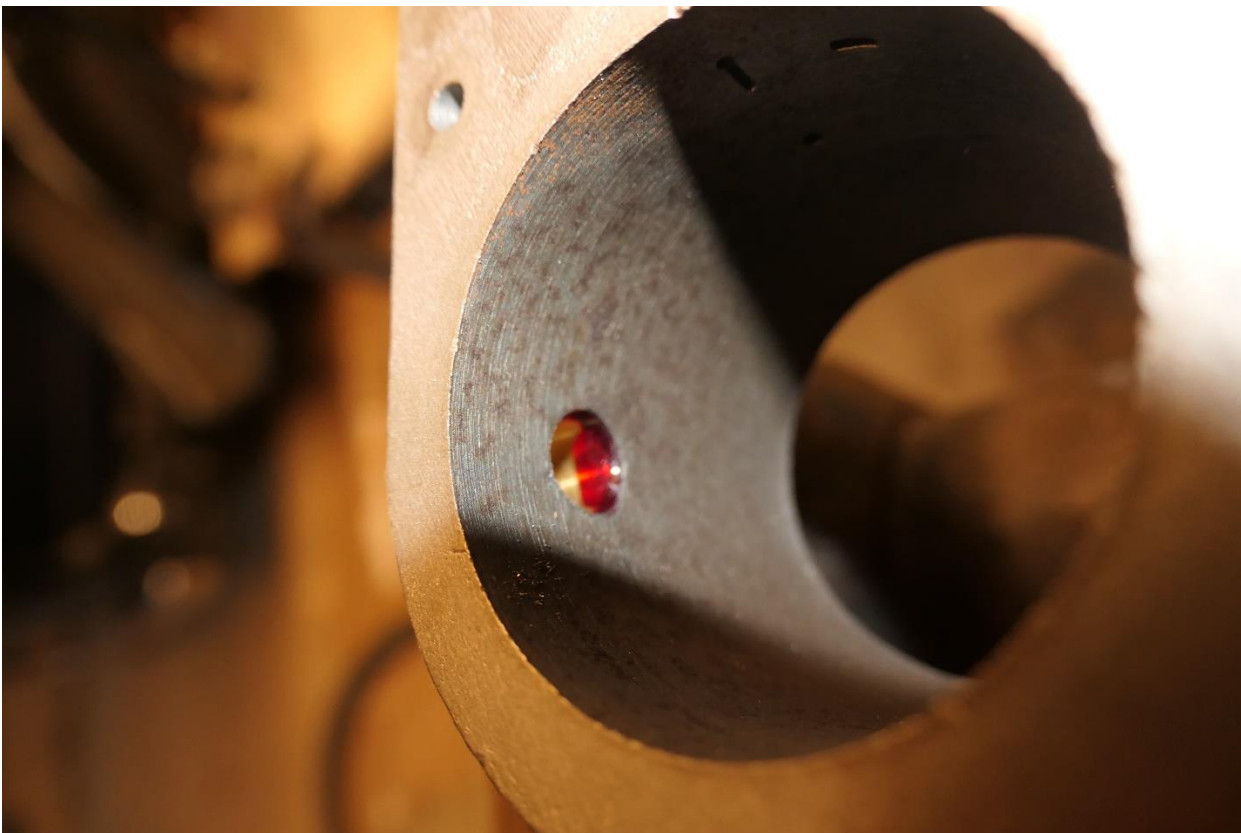
Remove excess Locktite promptly using the Throttle Shaft to push out the excess:

Re-examine the clearances now after both bushings are installed.

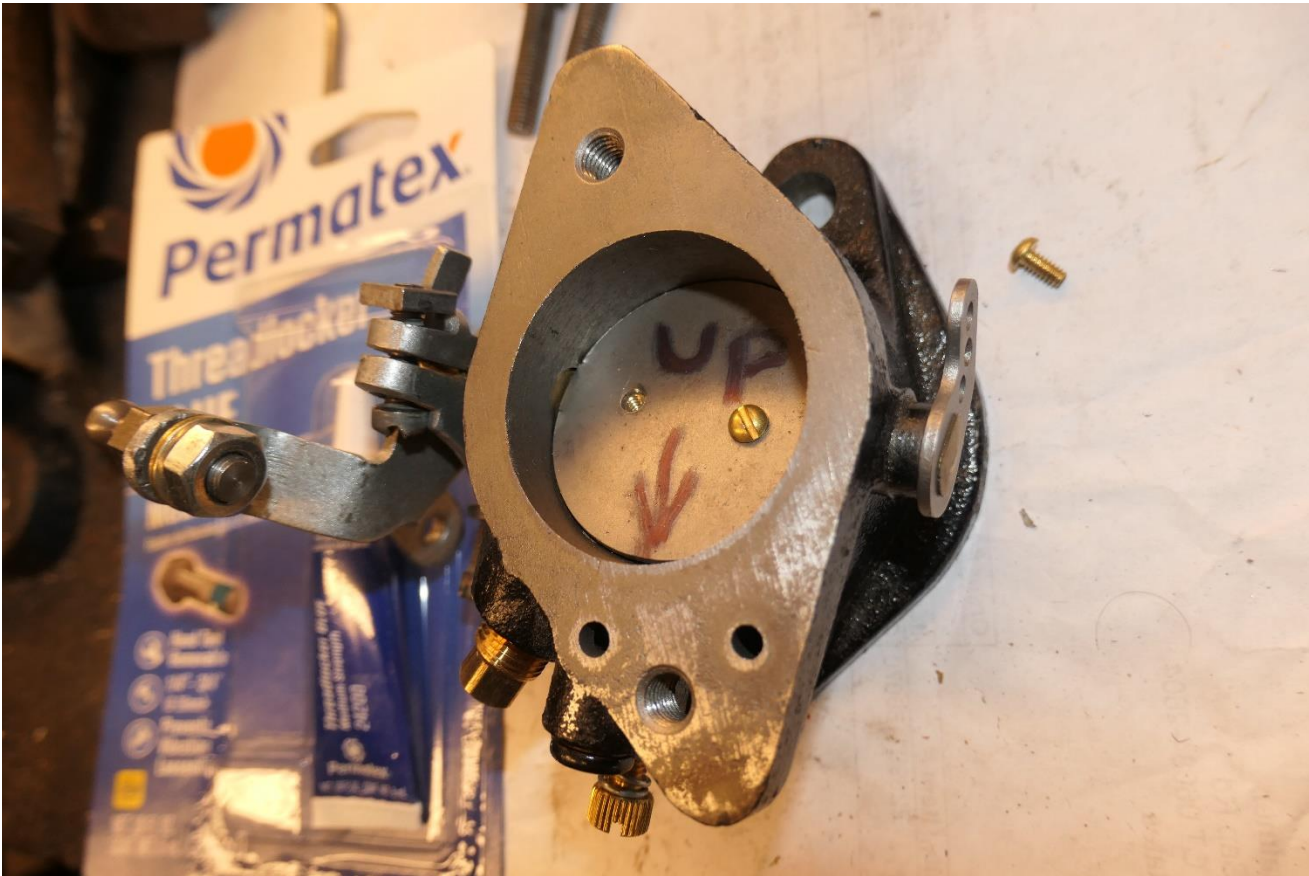
Make sure the Throttle Valve install is in the correct orientation and the lever on the Throttle Shaft points in the correct direction. Once Throttle screws are installed with medium strength Locktite removing them could be challenging if your Throttle Shaft and Throttle Valve positions are not correct the first time:

Do not use High Strength Locktite as it's likely screw removal will end up in broken screw pieces in the Throttle Shaft when the screws break off.
