## Distributor Cap/Rotor Quality Check

The Distributor Cap/Rotor Quality Check provides info on verifying that your cars vintage engine new Cap & Rotor (CR) combination (as factory machined) are good to use. Best to do the inspection since the manufacturer of each part didn't mount the C/R on your distributor & verify the results meet specifications. Why? Ignition component life & engine starting/idling/running can be adversely impacted if CR restrict ignition excessively.

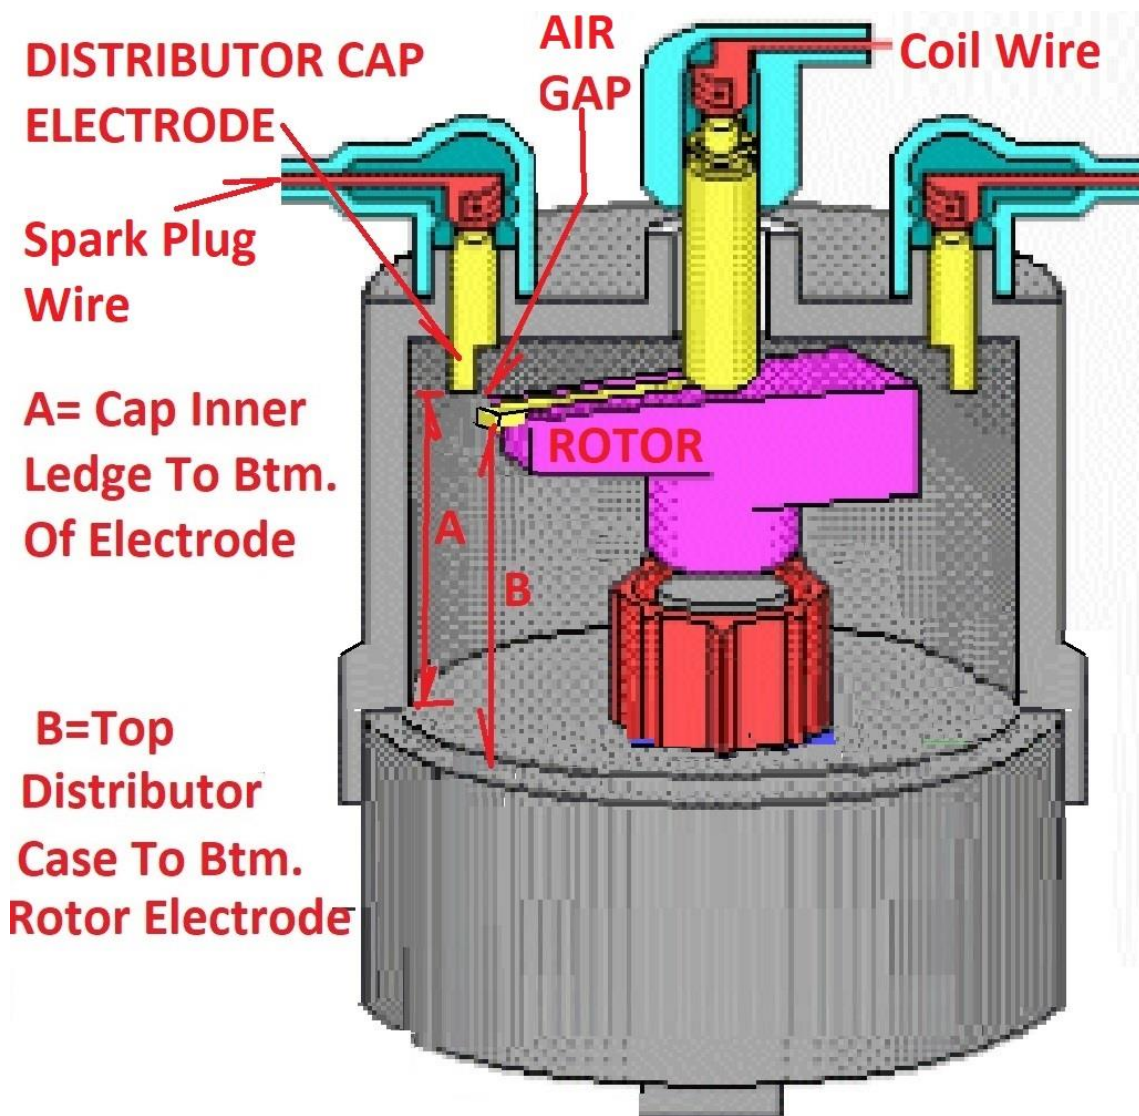
The CR direct the ignition coil output to the correct spark plug at the right time. The "connection" in the cap between the spinning rotor and the cap electrodes (for each spark plug wire) is actually an air gap which the coil power must bridge when the rotor points at the cap electrode as illustrated below:

Large Air Gaps causing high resistance force a coil to push harder = higher coil wire voltage.

There is one Gap measurement you can take standing in the store with potential cap in hand; the UP/DOWN Gap. Look back at the illustration showing two dimensions A & B. Dimension A measures how far the cap electrode is from the shelf where the cap sits on the distributor and provides one part of the data needed to determine the UP/DOWN gap.

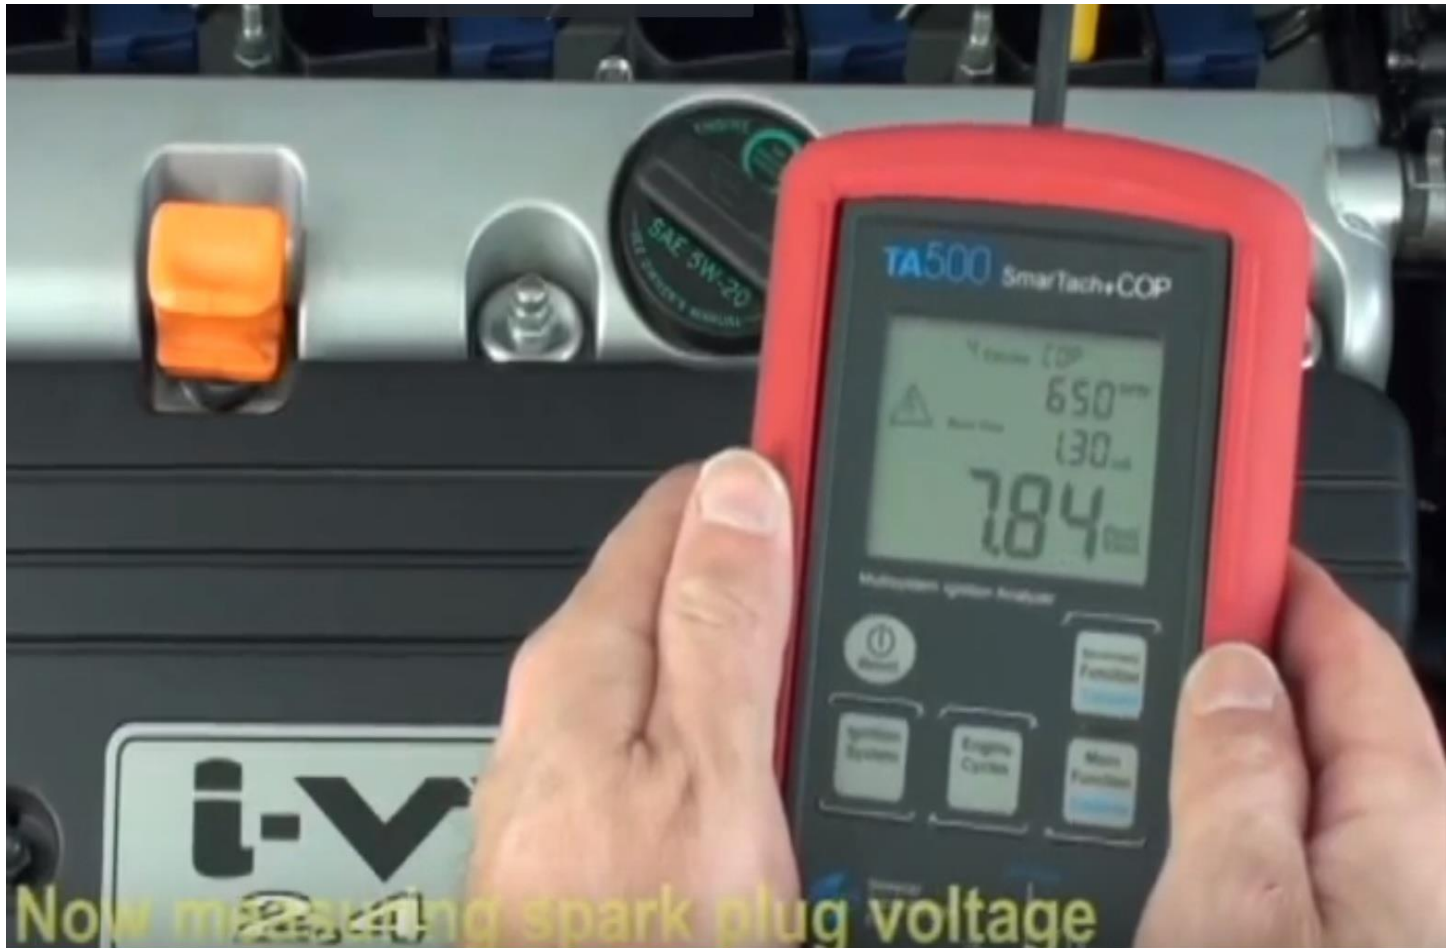
Some equipment is made to measure these coil wire voltages without disturbing any part of the ignition system; the measuring “meter” slips around the coil wire & flashes the voltage:

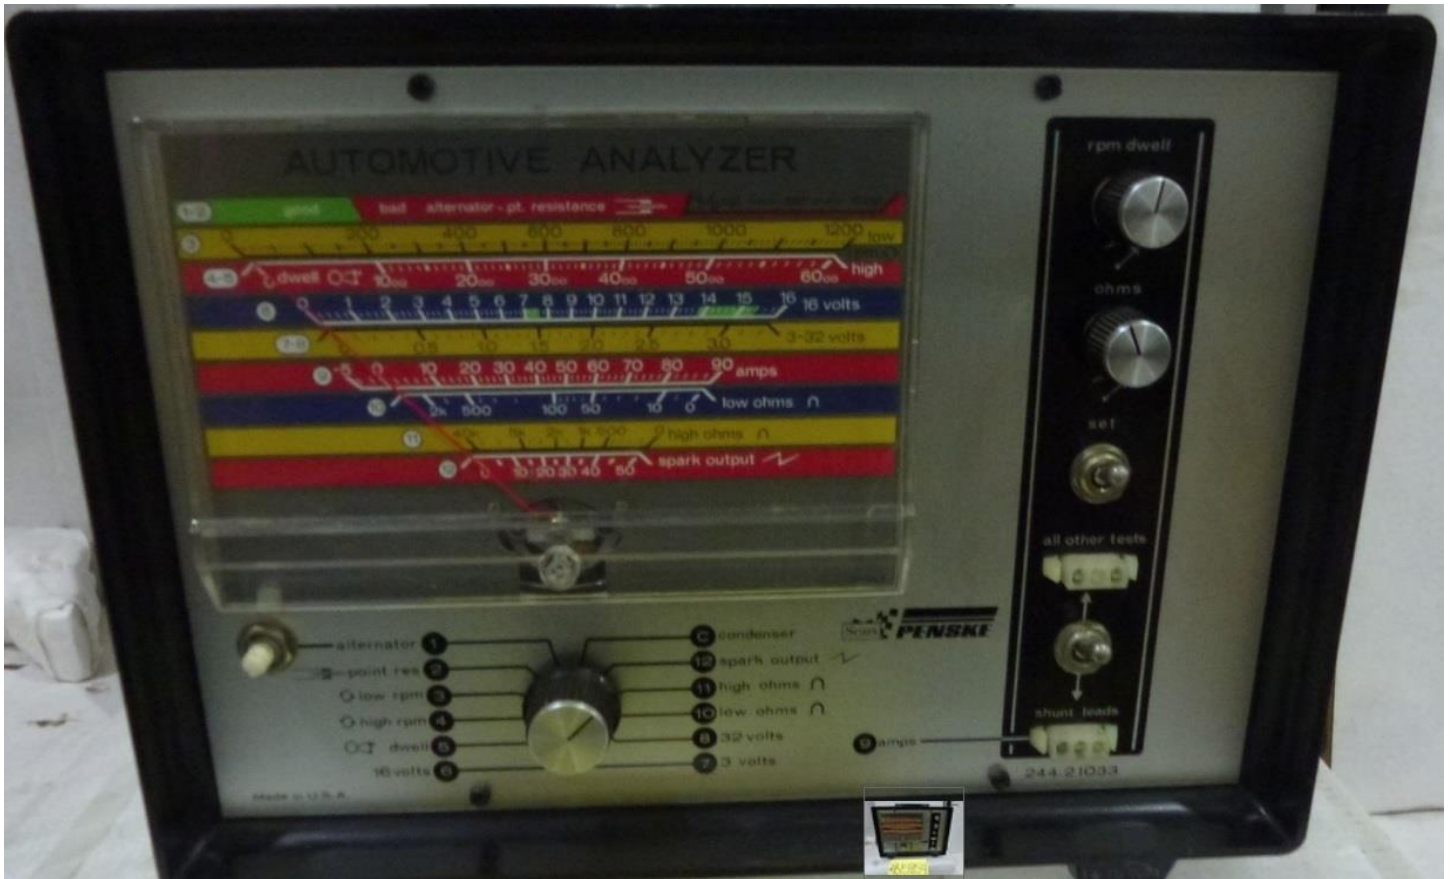
A less expensive approach (older test equipment) is an analog ignition analyzer such as the following including a Spark Output function which provides measurements up to 50,000 volts:

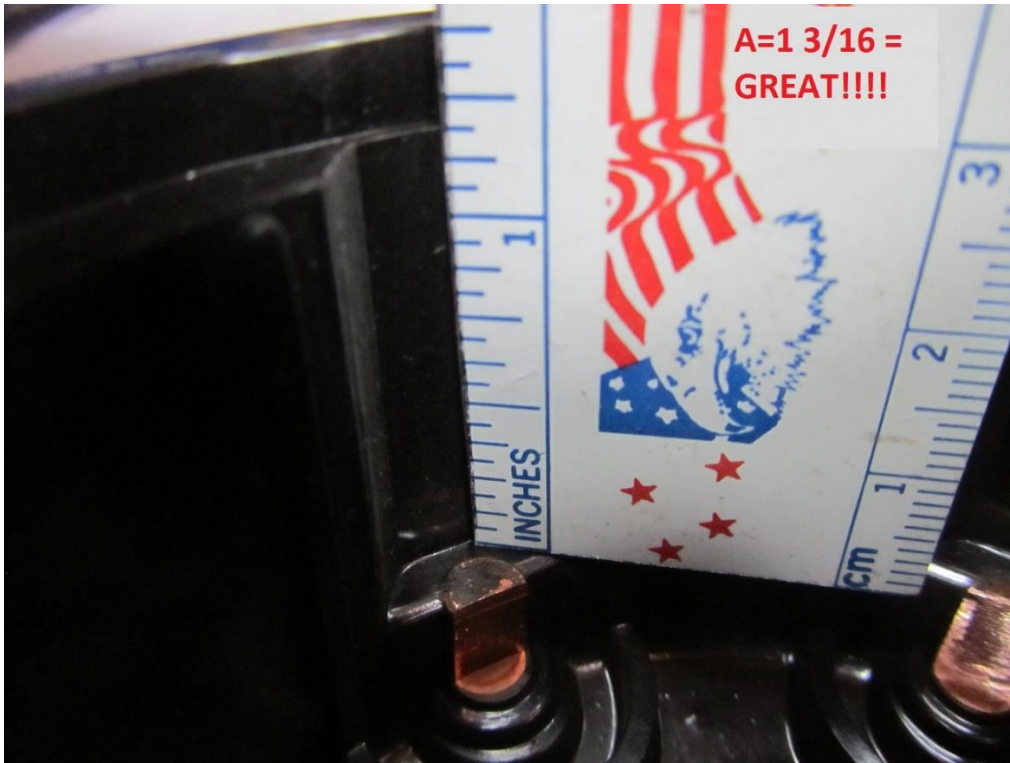
Dimension A example is  $1 \frac{3}{16}$  from the electrode to the distributor cap shelf:

The following example shows an excellent & acceptable condition with the A dimension equal or slightly less than the B dimension. The UP/DOWN Gap is considered zero as desired.

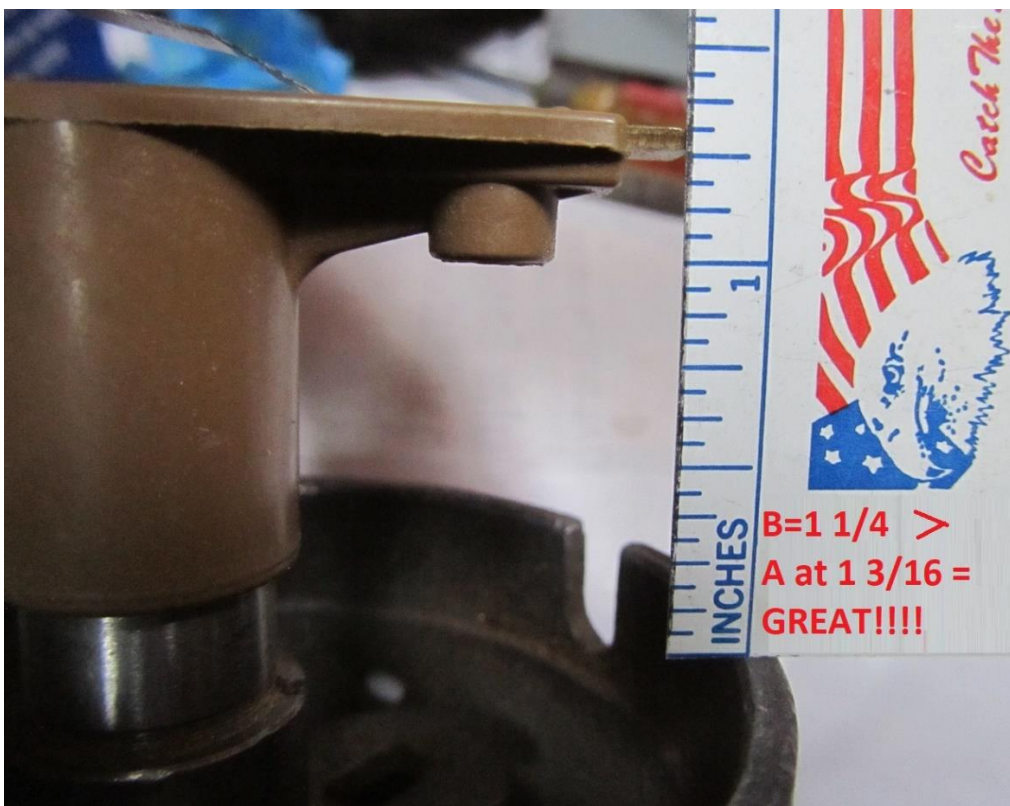
Dimension B is  $1 \frac{1}{4}$  from top of distributor casting to bottom of rotor tip:
