Early A-Body Quarter Panels

A recent question about rear lower quarter repairs on a Mopar Early A-Body suggested this article. Some 60's Valiants and Darts fall in this category.

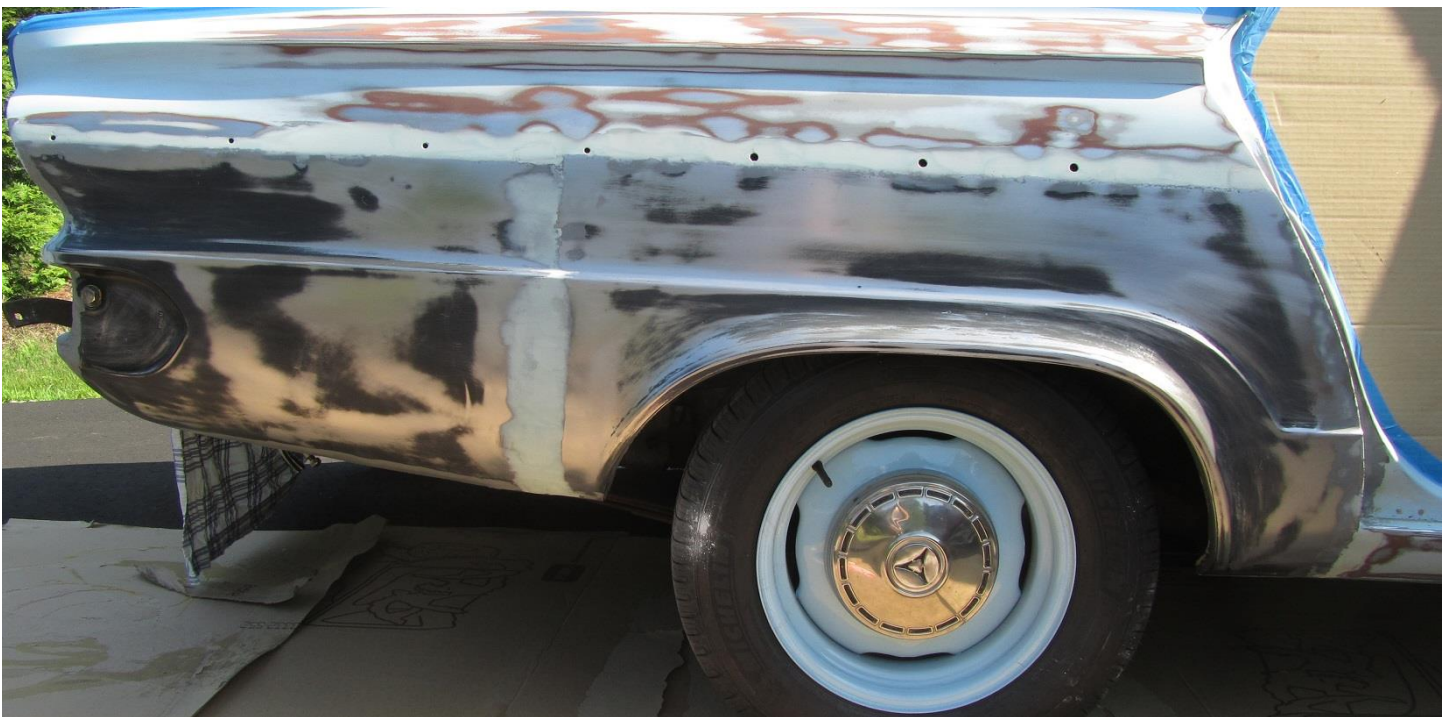
Below pictures show quarter panel repair on a 65 4 door. The front lower rear quarter repair panel (FLRQRP) extends to the door line which put the front vertical weld right on the bend of the door opening which I considered a nice location for blending in the weld. The FLRQRP (as purchased) extended all the way back to several inches beyond the tire opening which I considered an advantage so as to place the butt welding in a relatively flat area of the panel. This feature eased the blend welding and final body work outside the sharp contours of the wheel opening bead.

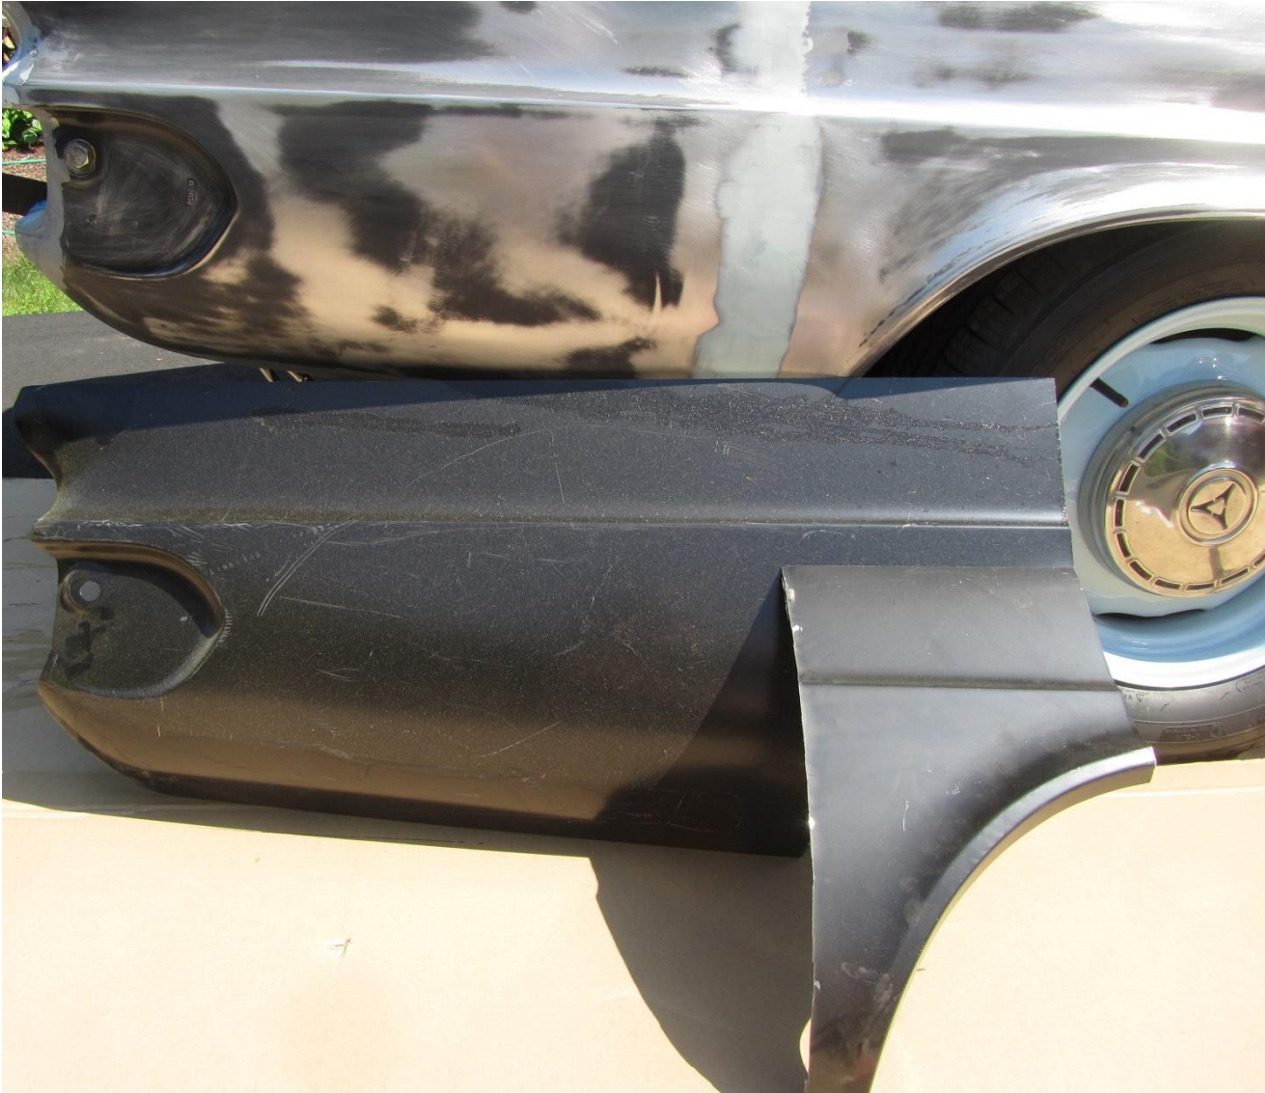
In the above picture note the FLRQRP was installed as received without any modifications but the rear panel had to be cut to match the FLRQRP. The cutoff can be seen in the picture.

An accurate cut line was achieved by temporarily installing the rear lower panel first (use bumper bolt, upper trim holes for clamping bolts/washers, and welding clamps at the lower edges of the panel). Then the front panel was laid over the rear panel and a scribe mark made at the future butt welding seam.

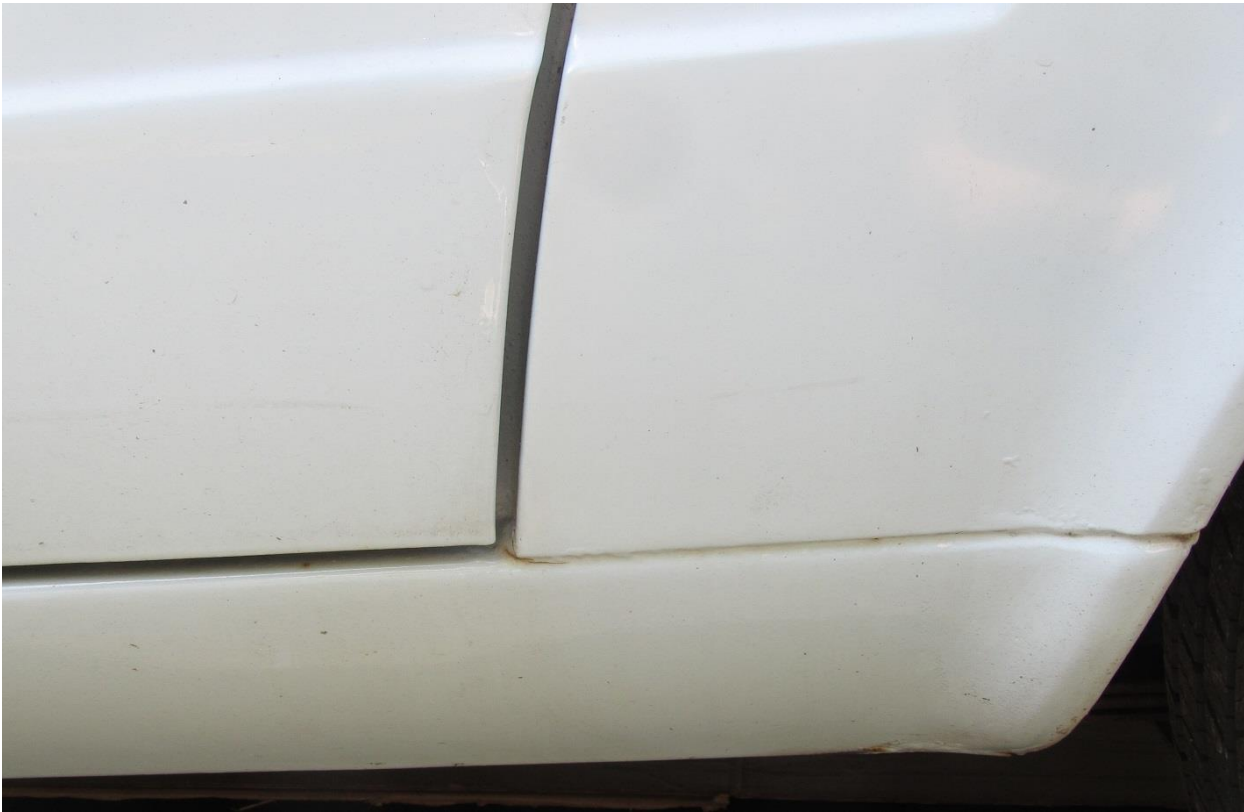
The next area to be noted is the normal rocker panel seam and the new FLRQRP seam differences. The OEM rocker panel seam is horizontal along it's entire length right up to the wheel well. The new FLRQRP places it's seam vertical at the edge of the door. This may be of importance to those wanting a strict OEM look. Some may see an advantage to the vertical seam in that it reduces rust out that occurs between the rocker panel seam and the quarter panel seam in front of the wheel well. The factory OEM horizontal rocker panel seam:

The above show the rust creep starting along the seam. The following picture occurs when the FLRQRP is installed with the vertical seam virtually eliminating the horizontal rocker seam:
