"Engine & Secondary Ignition Physical Part 3" restoration article is inspired by the upcoming May 2019 "Tech Event" being hosted by the Nichols at their home.

Part 3 covers applying this knowledge to an example; 65 Dart(Slant Six) with excess secondary voltage measured in the 2018 Engine Secondary Ignition Physical. Applying the theory of only changing one thing at a time the 2019 65 Dart Ignition Physical was performed (Trail 1) after altering the design of the spark plug wires by changing wire types & altering routing for the unique slant 6. Wire types originally were 8.5mm EMI & were changed to 8.5mm non EMI:

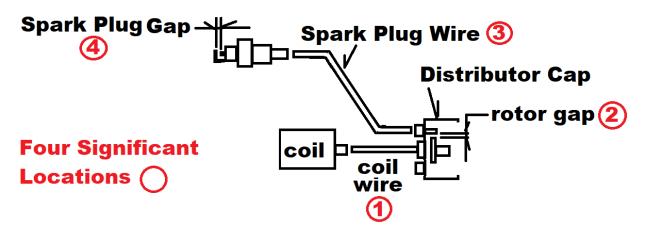
## **Vintage Car Secondary Ignition Resistance Locations**

Part 1 covered the need for having ignition data on your unique vintage car, getting a routine "physical" to collect present data, & finally delved into some secondary ignition resistances:
