Balancing Tail Light Intensities article is the result of a Colonial Region member pointing out that the brightness of the lights appeared out of balance on the rear of my 65 Mopar. There are 4 light assemblies in this case with the outer lights displaying brake & tail lights while the inner lights were tail lights only. A Tail Light Assembly consists of rim, lens, reflector, and gaskets:

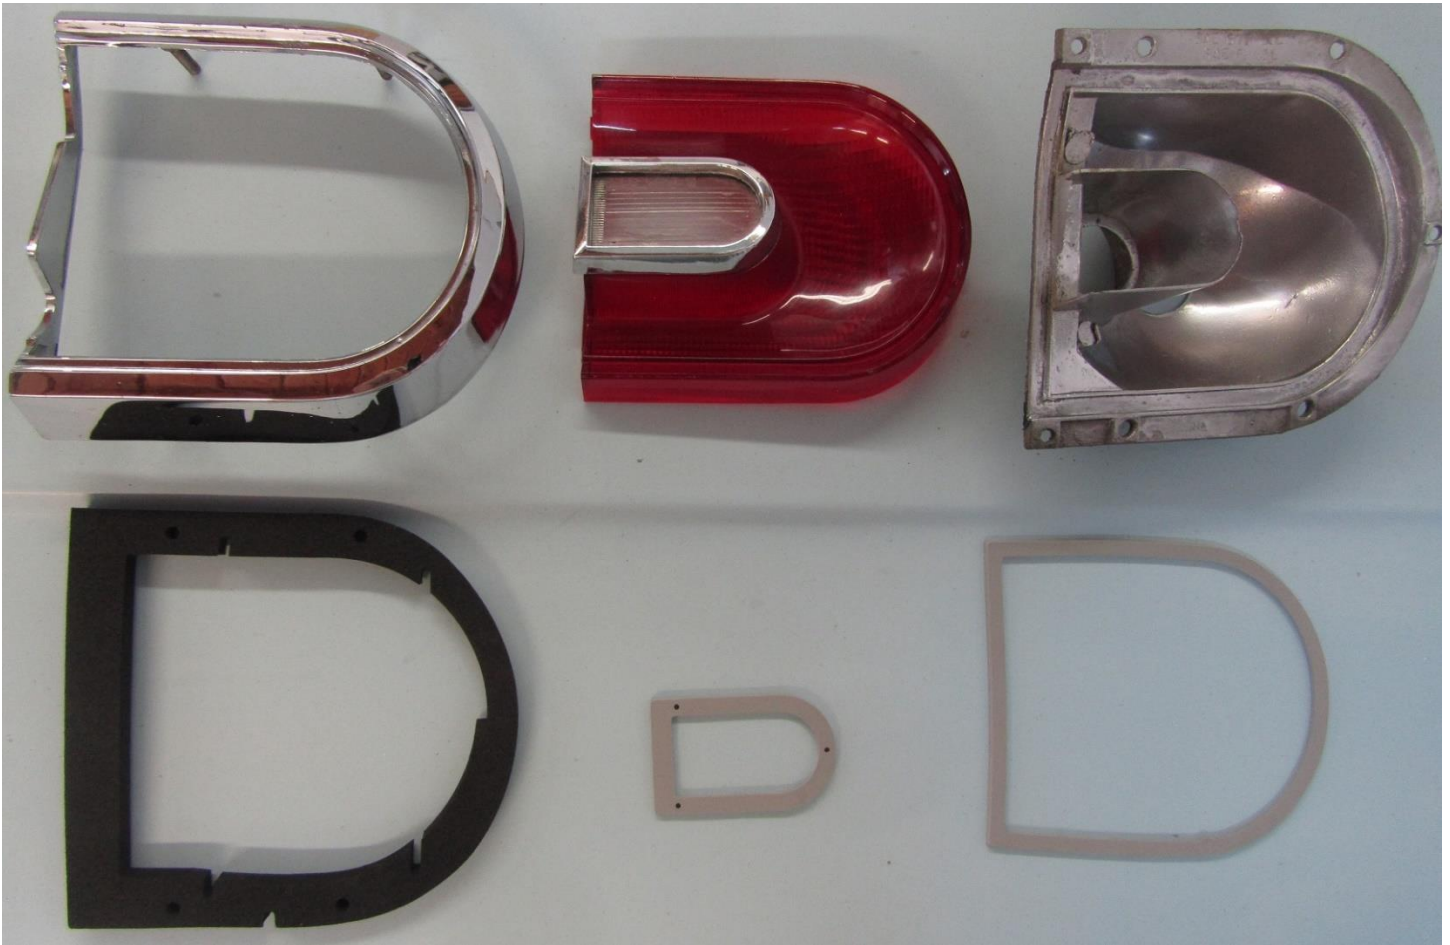
The overall theory was that not only were the effects of gasket, UV, dirt, and oxidization deterioration over time involved but also the original design involved high heat producing incandescent bulbs held close to the lens caused a significant lens failure. Have someone step on the brake for awhile and touch the lens (or use a temp gun) to see if your lens has a hot spot near where the bulb is located. If your current lens has distortion, has turned white, or cracked in that area your lens may be failing from the effects of the heat source placed too close too the lens such as in this condition:

- 1) Removing tail lights assemblies, disassembling, & washing dust & mud off inside of red lenses
- 2) Cleaning dust off reflectors
- 3) Removing faulty/leaky gaskets
- 4) Replacing some deteriorated lenses (caused by heat off the excessively close incandescent bulbs & UV (sun))
- 5) Using new gaskets
- 6) Spraying cleaned reflectors with highly reflective "chrome" paint
- 7) Replacing oxidized light sockets
- 8) Adding grounds to each light assembly
- 9) Replacing all light bulbs with identically marked new bulbs from same package after (wait for it.....)
- 10) Converting inner single filament tail light sockets to..... dual tail light sockets
- 11) Wiring inner tail lights such that only the inner tail light portion of the inner sockets would be functional only
- 12) Upgrading each bulb to LED type to reduce heat generated under nearby lens
